PrecisionHD 4X Camera Connectivity Problems

Recently camera connectivity and camera boot problems with PrecisionHD 4X cameras (CTS-PHD-1080P4XS1=) have been reported in the field. We have narrowed down the reported problems to three scenarios:

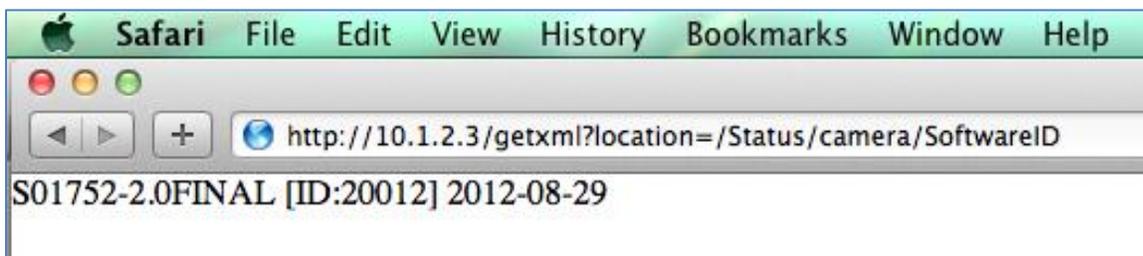
The camera firmware version containing the fix is found in 20011 and later. The current camera firmware version is found by viewing the softwareID as shown in “xstatus camera” (screenshot below). Fixed camera firmware is bundled with TC4.2.4 and TC5.1.3 or later codec software.

Once the camera has been successfully been upgraded, a similar output as shown here should be seen when issuing the “xstatus camera” command:
