Multicast Case Sharing

Chen Fei

2014/7

Case 1: Traffic Problem

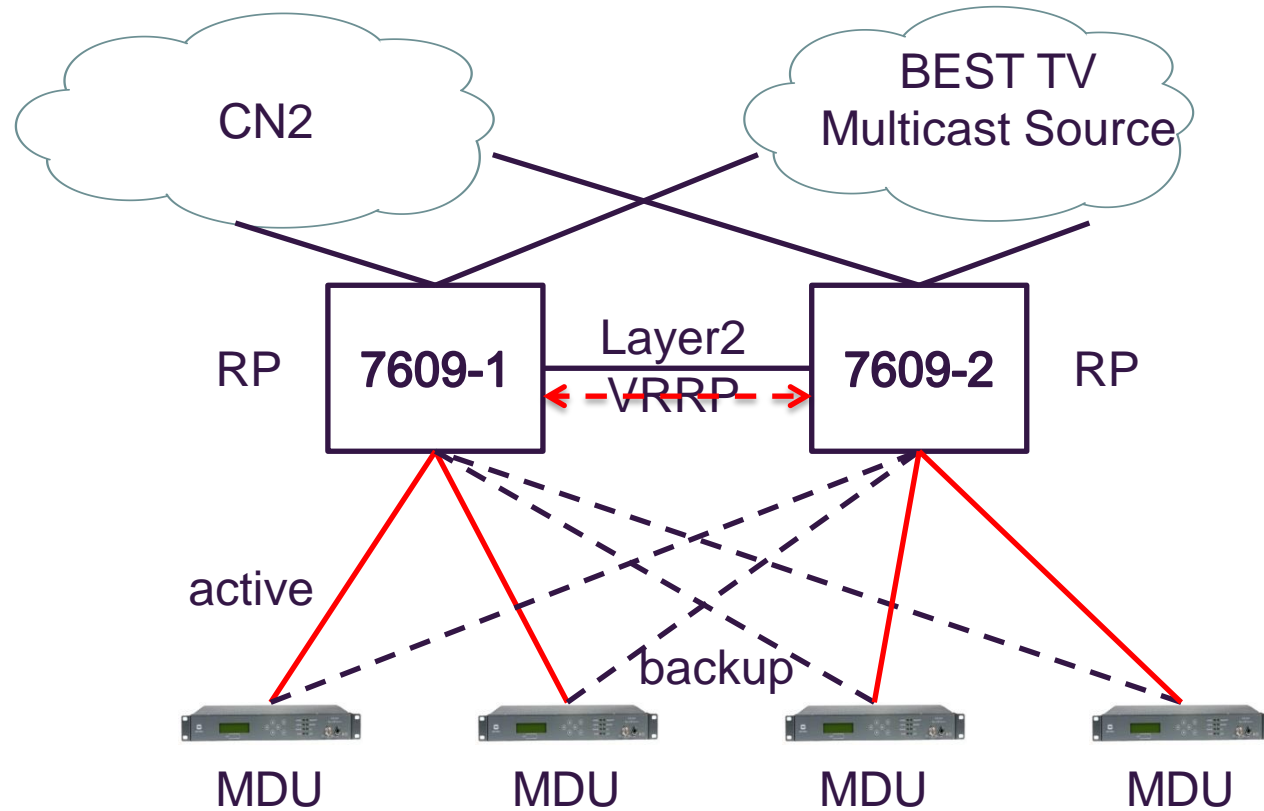
Customer Topology

- MDU report that some multicast channel did not retrieve at MDU.
- Check the multicast entry on 7609-1, (*,G) entry exist, the interface VLAN 12 which MDU connected are listed on outgoing interface list. But (S,G) entry did not create.

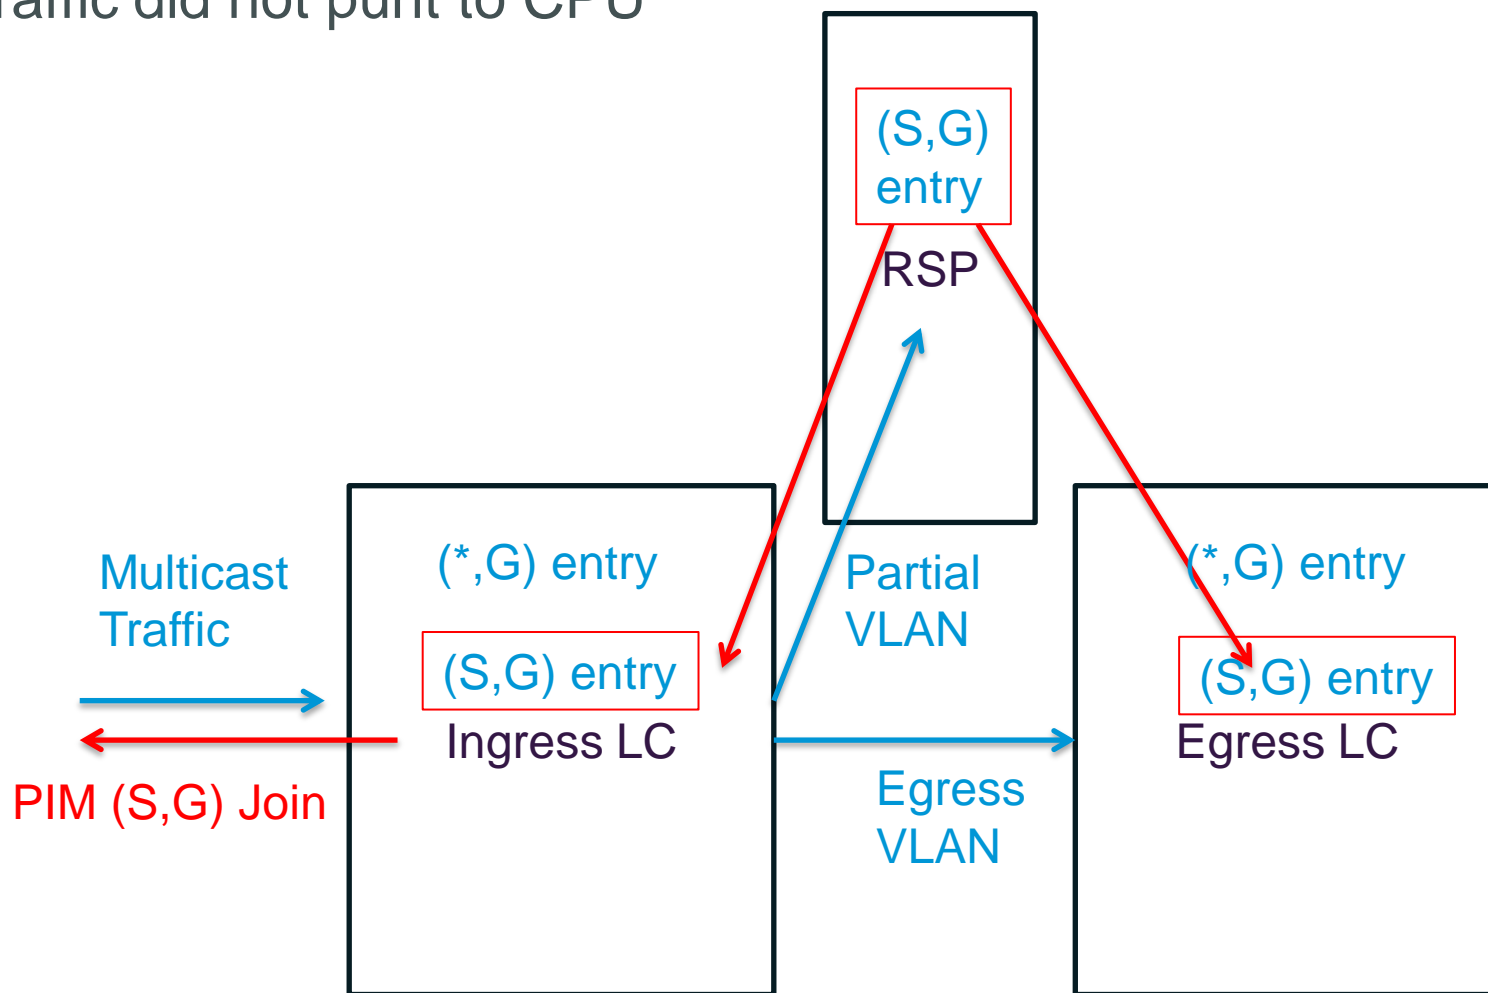
MET2 entry is correct, next action plan

ttl=1, so multicast packets will drop on this 7609

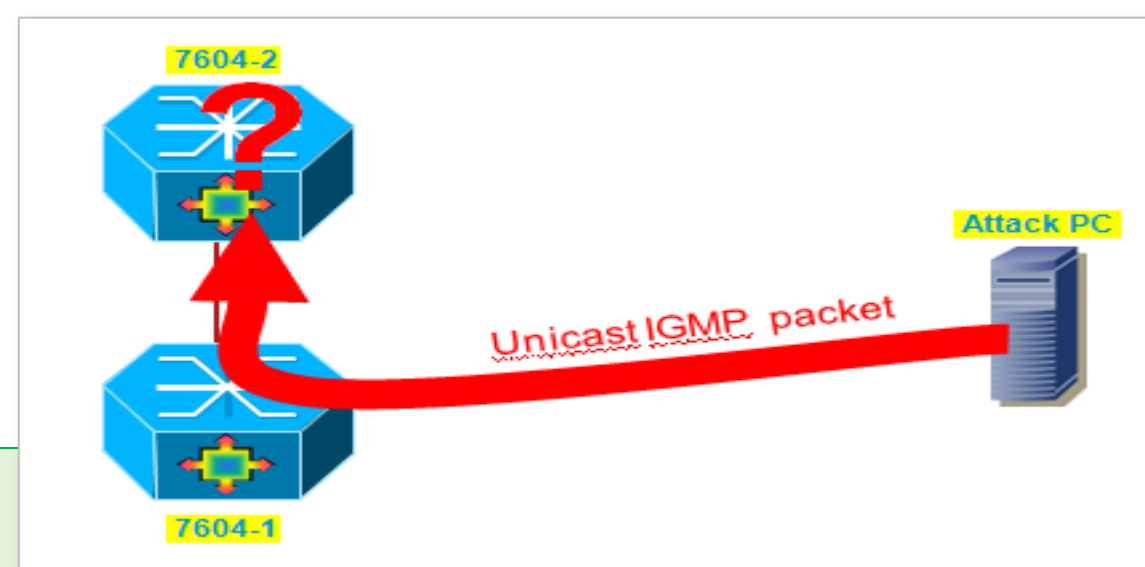
- Can create IGMP state on “remote” routers!!!
- Need to protect with iACL (blocking all traffic to “internal” routers); and/or mls rate limiters;

We created outgoing state on the interface the IGMP was received on!!!

NOT EXPECTED

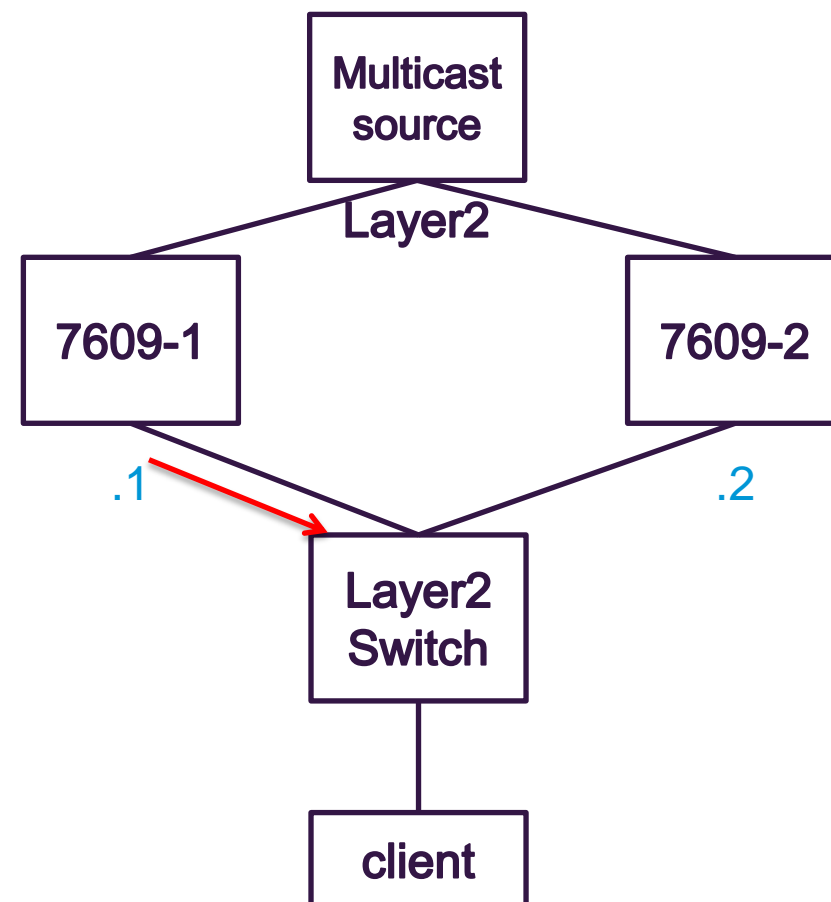
So the AD and metric are both 0. directly connection link, so the interface with HIGH IP address, will be the forwarder.

It makes our network design ruin.

*May 29 23:57:19.495: PIM(0): **We lose, our metric [0/0]**

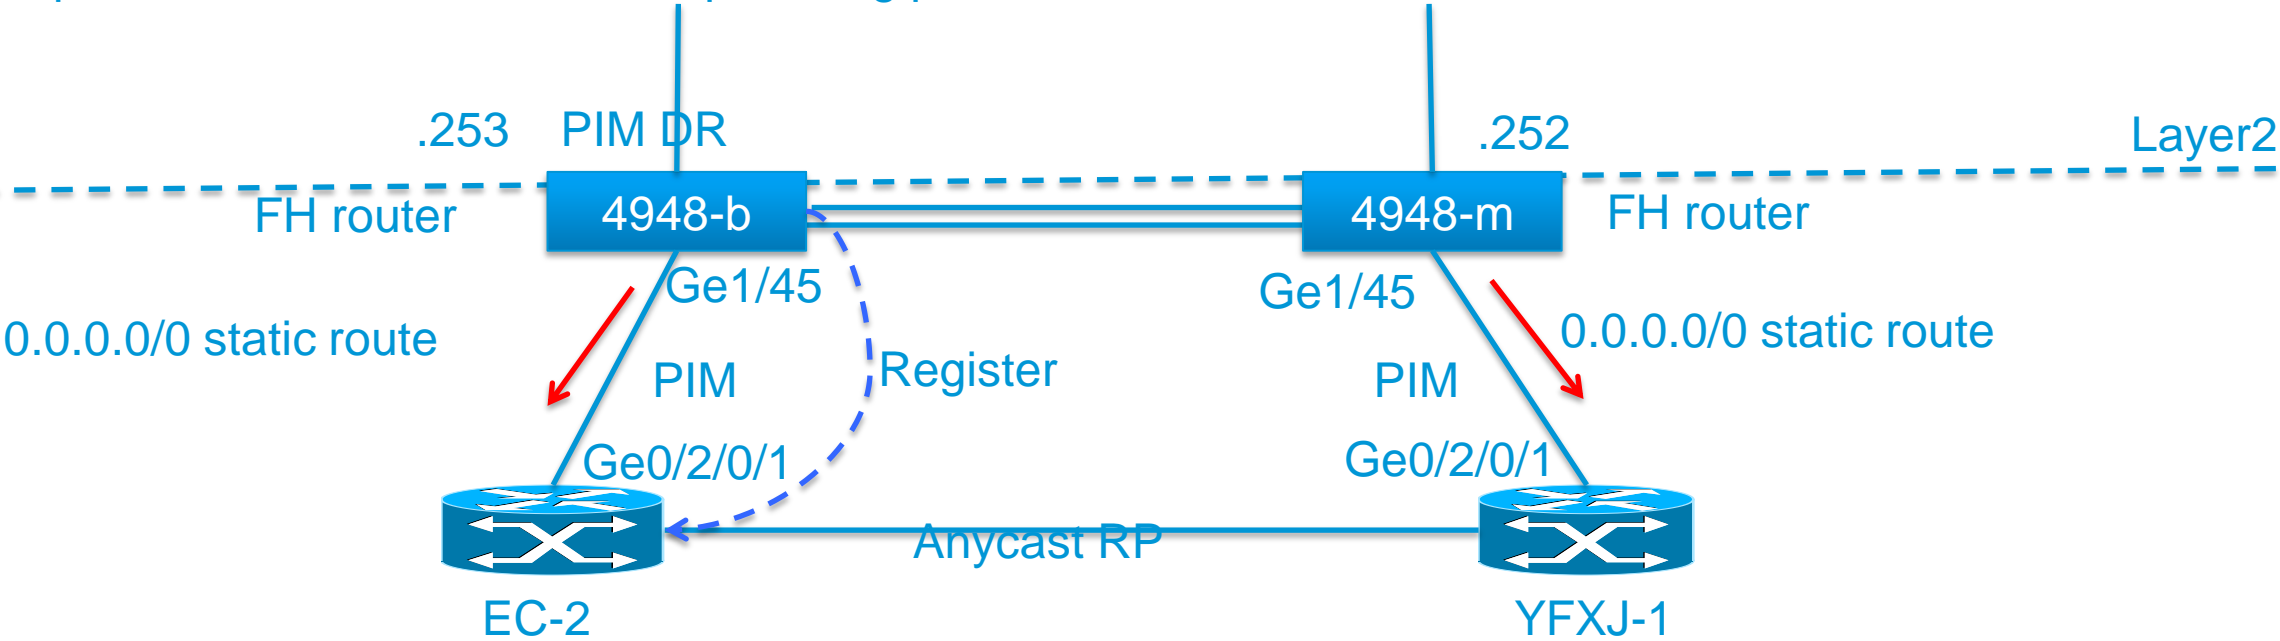
When the interface between 4948-b and EC-2 is down, 4948-b still is DR for VLAN 111, so it still need send out register packets to RP, but did not find any routes to RP. So the register packets stuck in CPU more and more. Leads to CPU high.

The same reason, due to YFXJ-1 RP did not receive any register packets from DR, the PIM entry can not set any flag.

In RP KeepaliveTimer(S,G) is restarted at the RP when packets arrive on the proper register tunnel interface. So the KAT and RR flag only set after receive the register packets from DR.

When the 4948-b restart the RP will be switched to 4948-m, so 4948-m sends out the register packets, and service recovery. But if the 4948-b boot up. The service still will be down, if the interface between EC-2 and 4948-b still down.

Propose customer to set up backup static routes pointed to RP.
