We have identified this issue with the 4X camera with the following symptoms:

**To upgrade the camera manually:**

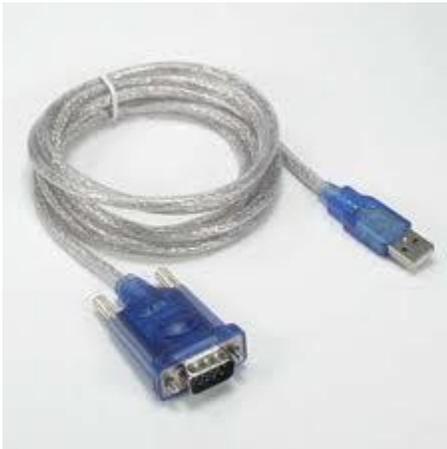
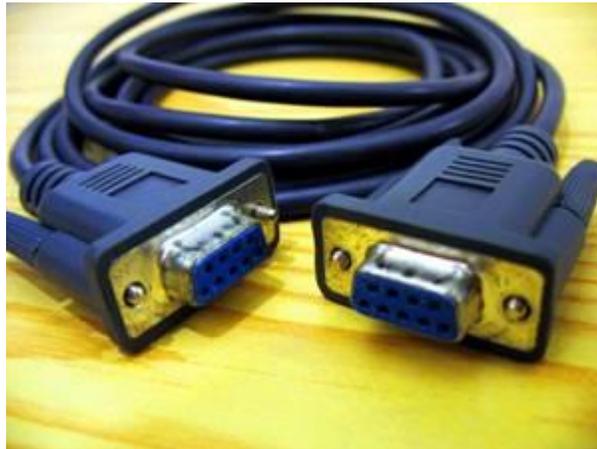
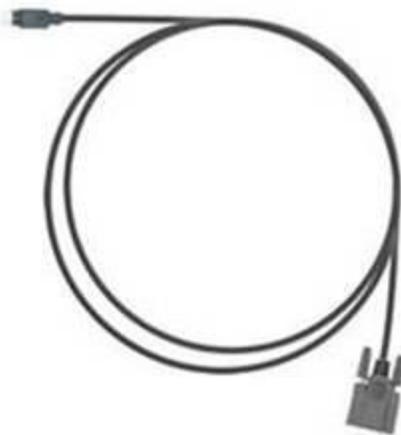
To upgrade the camera manually, you need the following cables:

- Camera control cable ( RJ45 to DSUB) shipped with C20
- Null modem cable
- USB to DB9 male

Below is the connection between camera and laptop:

**Laptop USB port > USB-DB9 (male cable)>NULL MODEM cable> DSUB9-RJ45 (camera control cable) > Camera RJ45 port**

Camera need to be powered using the external power supply. You can use C20 power supply in this case.
