How to Fix SRW Switch Issues With MS IE 6 Browser Windows 2000 and XP

Property of Linksys COBO QA
Version 1.0 April 23rd 2007
Authored by Razmik Mampourian

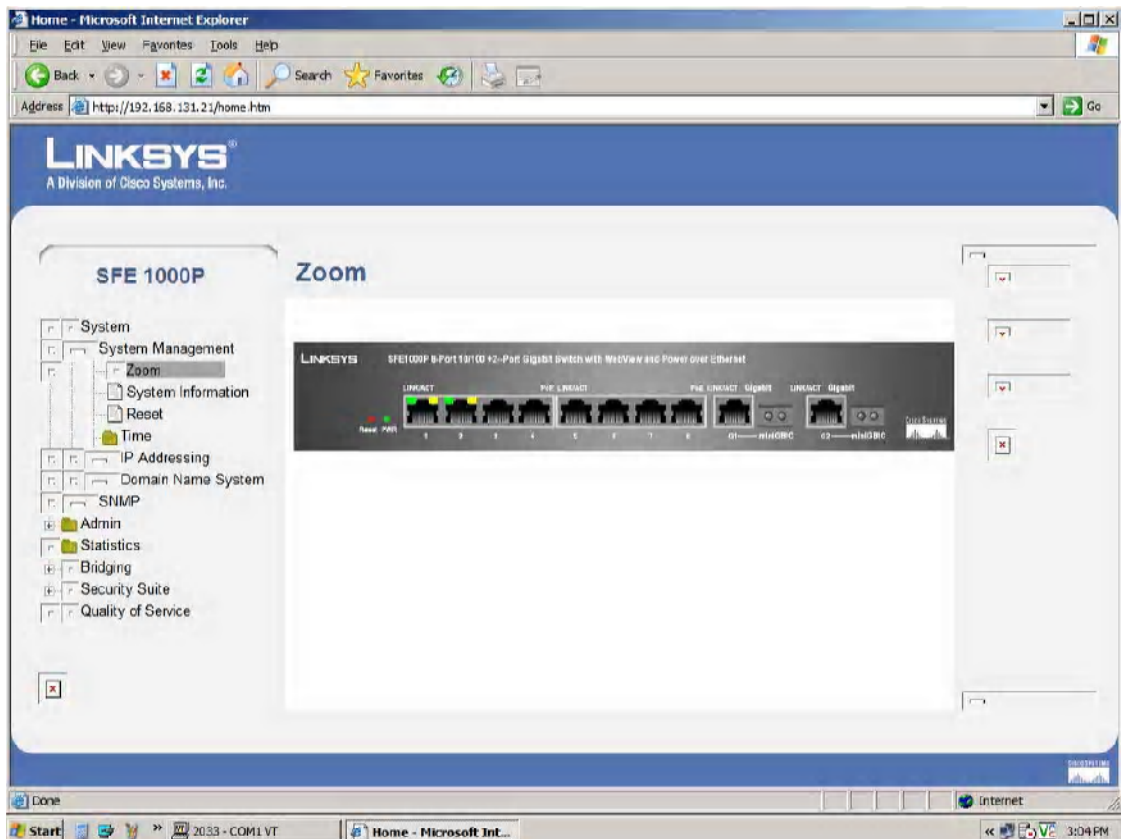
While managing SRW switch by Microsoft IE browser if page is not displayed completely as shown in Figure 1 then take the following steps to correct it.

Figure 1: Accessing the switch from a PC via IE browser.

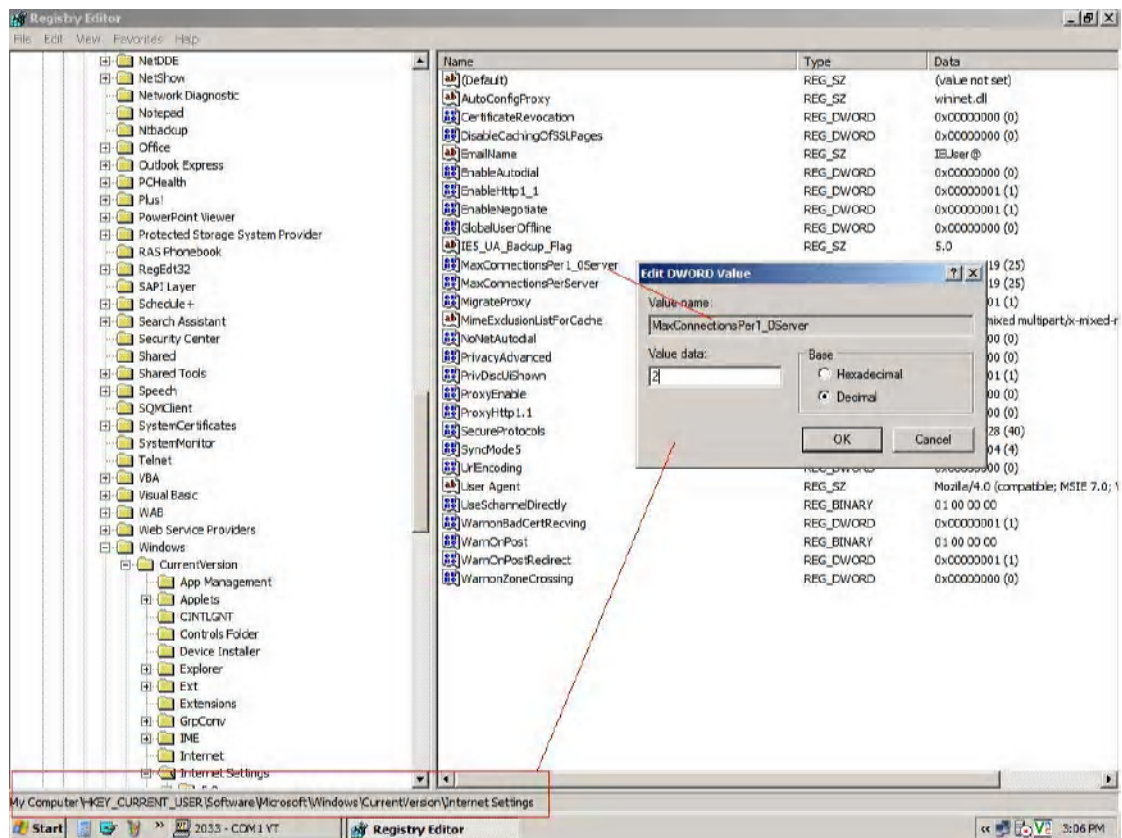
Figure 2: Locating "MaxConnectionsPer1_0Server" **and/or** "MaxConnectionsPerServer"

1. Run "regedit" and locate

"MaxConnectionsPer1_0Server" **and/or** "MaxConnectionsPerServer"

HKEY_CURRENT_USER\Software\Microsoft\Windows\CurrentVersion\Internet Settings

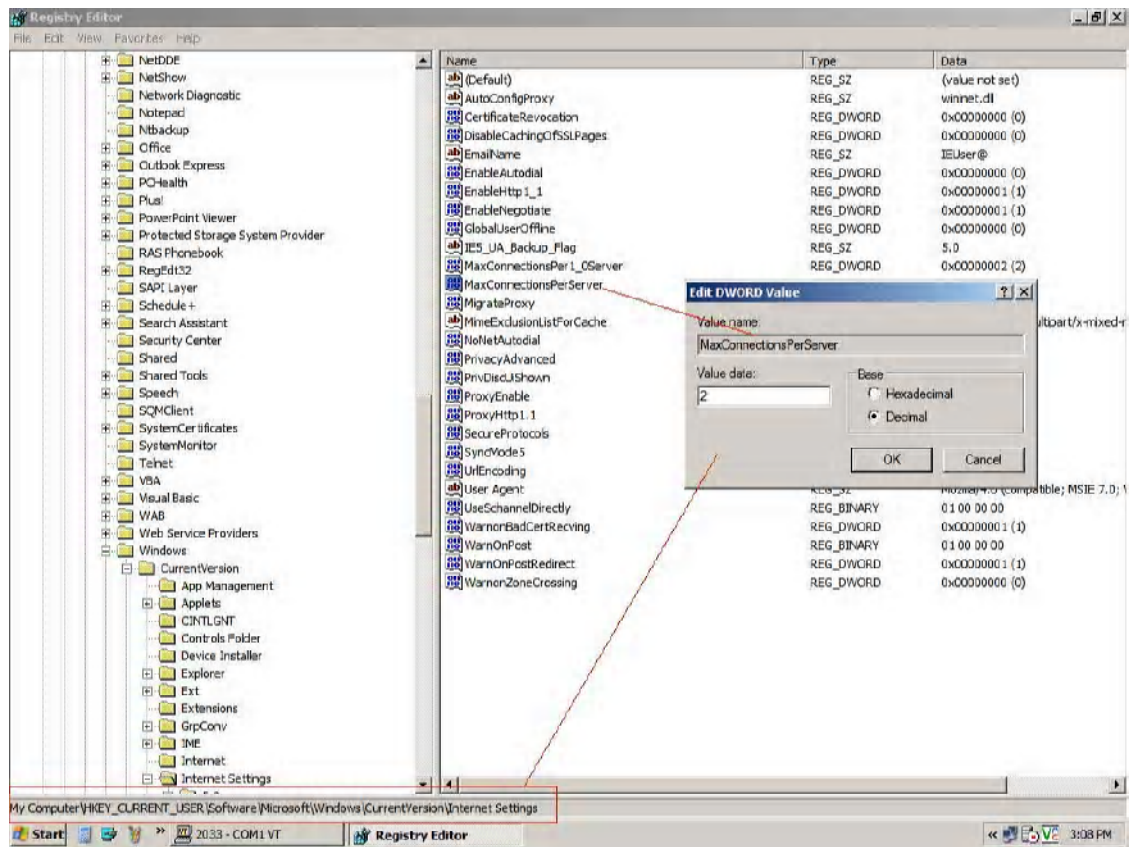
Figure 3: Modify DWORD values

2. Modify current set DWORD value back to default value of 2

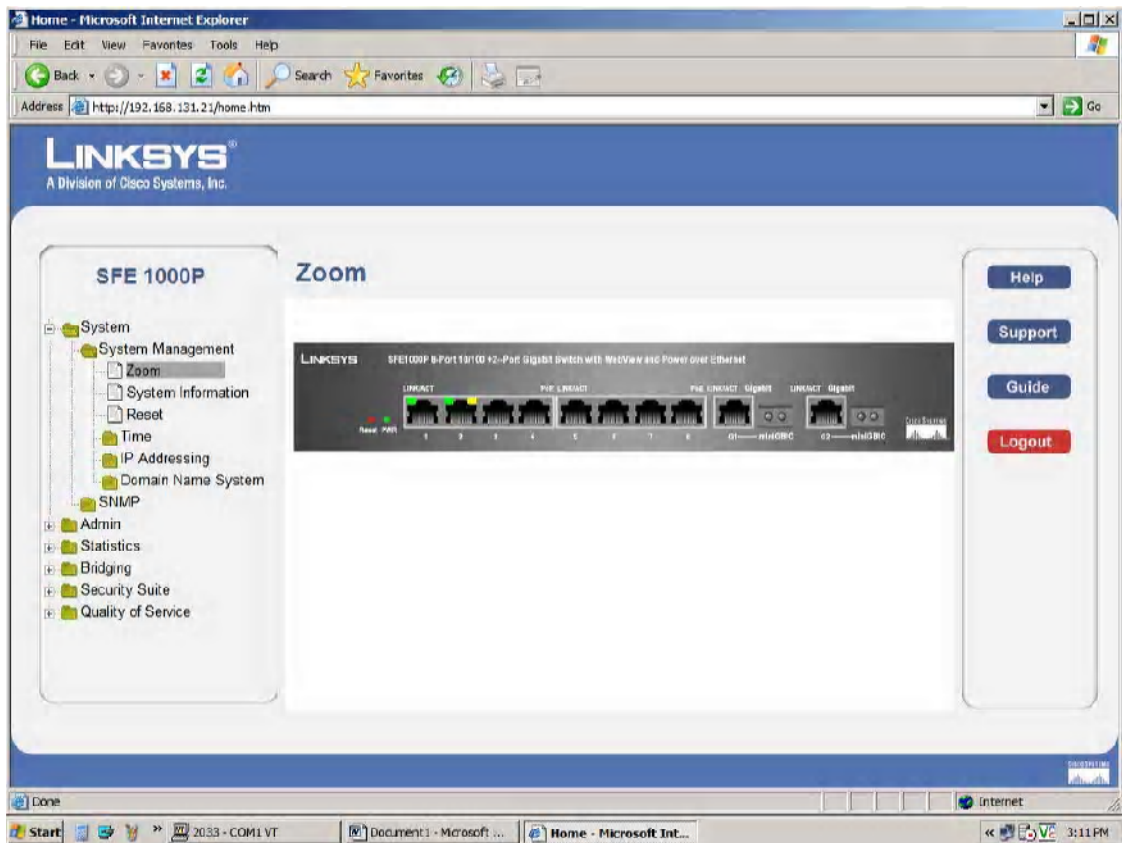
Figure 4: Final result

3. Access the switch again. Will notice the problem is fixed.
