Release Notes for Cisco Unified Communications UC320W Firmware Version 2.0.9

June 2011

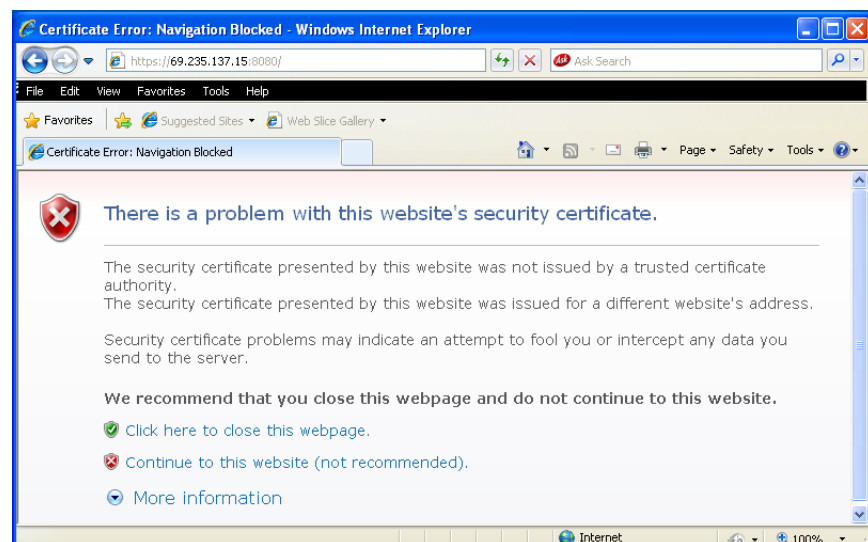
- On SPA50x models, press the Setup button and then choose the Language menu. Choose a language from the list, and then press Select.
 - On SPA525G/G2, press the Setup button and then choose the Device Administration menu. In the Language field, press the right-arrow navigation button, choose a language from the list, and then press Select.
- A certificate warning may appear when you connect to the configuration utility by using HTTPS. Refer to the example below. You can acknowledge the message and continue to the website. (CSCtn24097)
