Multicast Case Sharing

Chen Fei

2014/7

Case 1: Traffic Problem

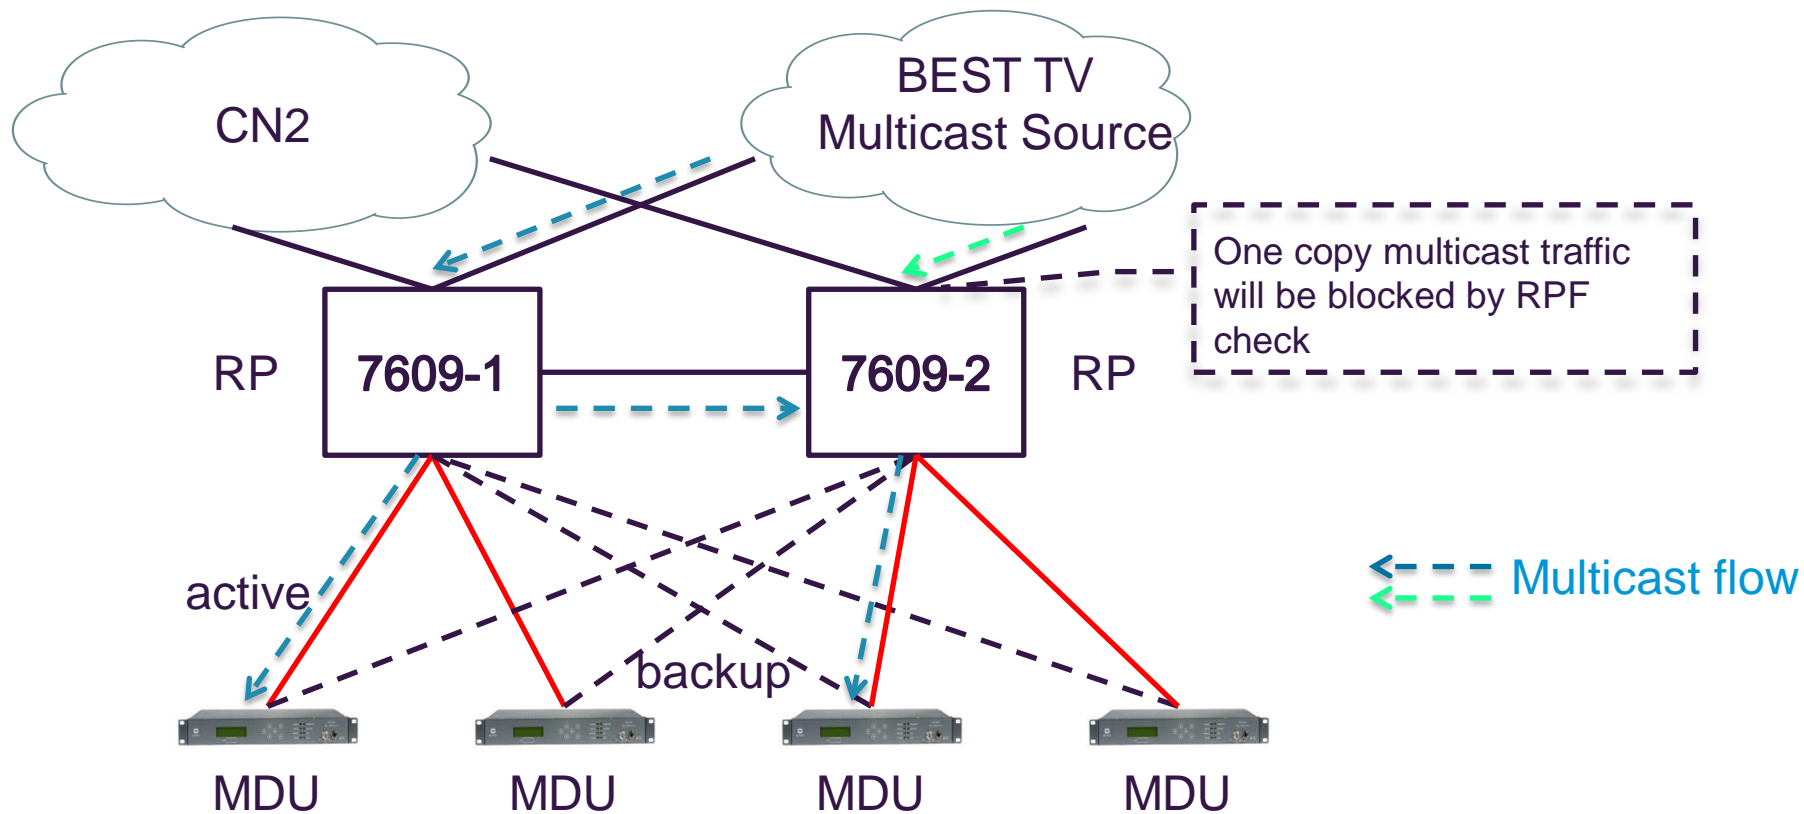
Traffic flow

- MDU report that some multicast channel did not retrieve at MDU.
- Check the multicast entry on 7609-1, (*,G) entry exist, the interface VLAN 12 which MDU connected are listed on outgoing interface list. But (S,G) entry did not create.

ttl=1, so multicast packets will drop on this 7609

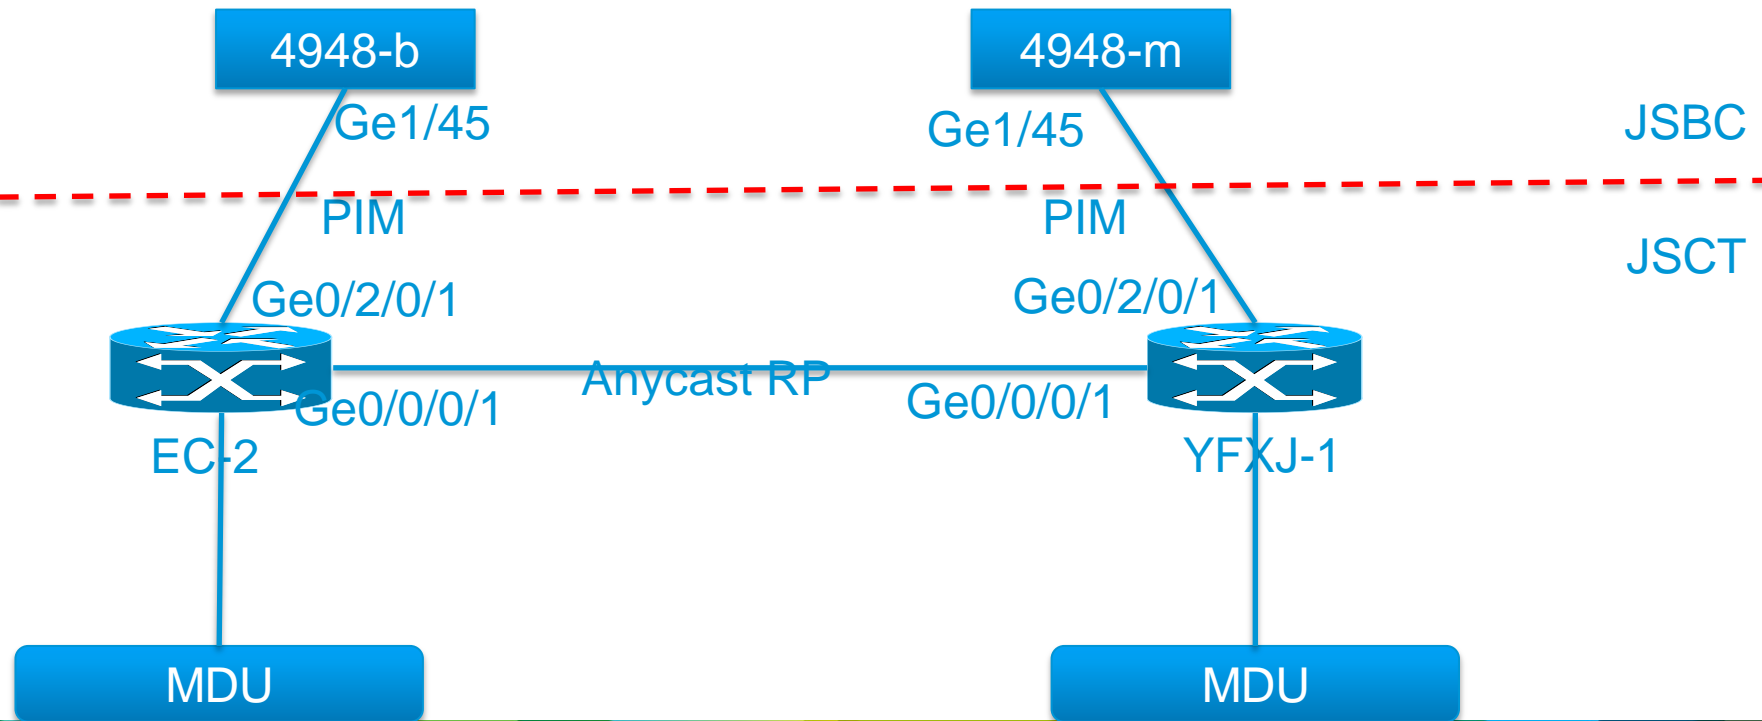
Network Topology

On my customer network two asr9k device is running Anycast RP to provide the protection for RP. IGP protocol is OSPF, running between them. Each device connected individually to one 4948 switch which belonged to content provider jiangsu broadcast. Between asr9k and 4948 is running PIM protocol.

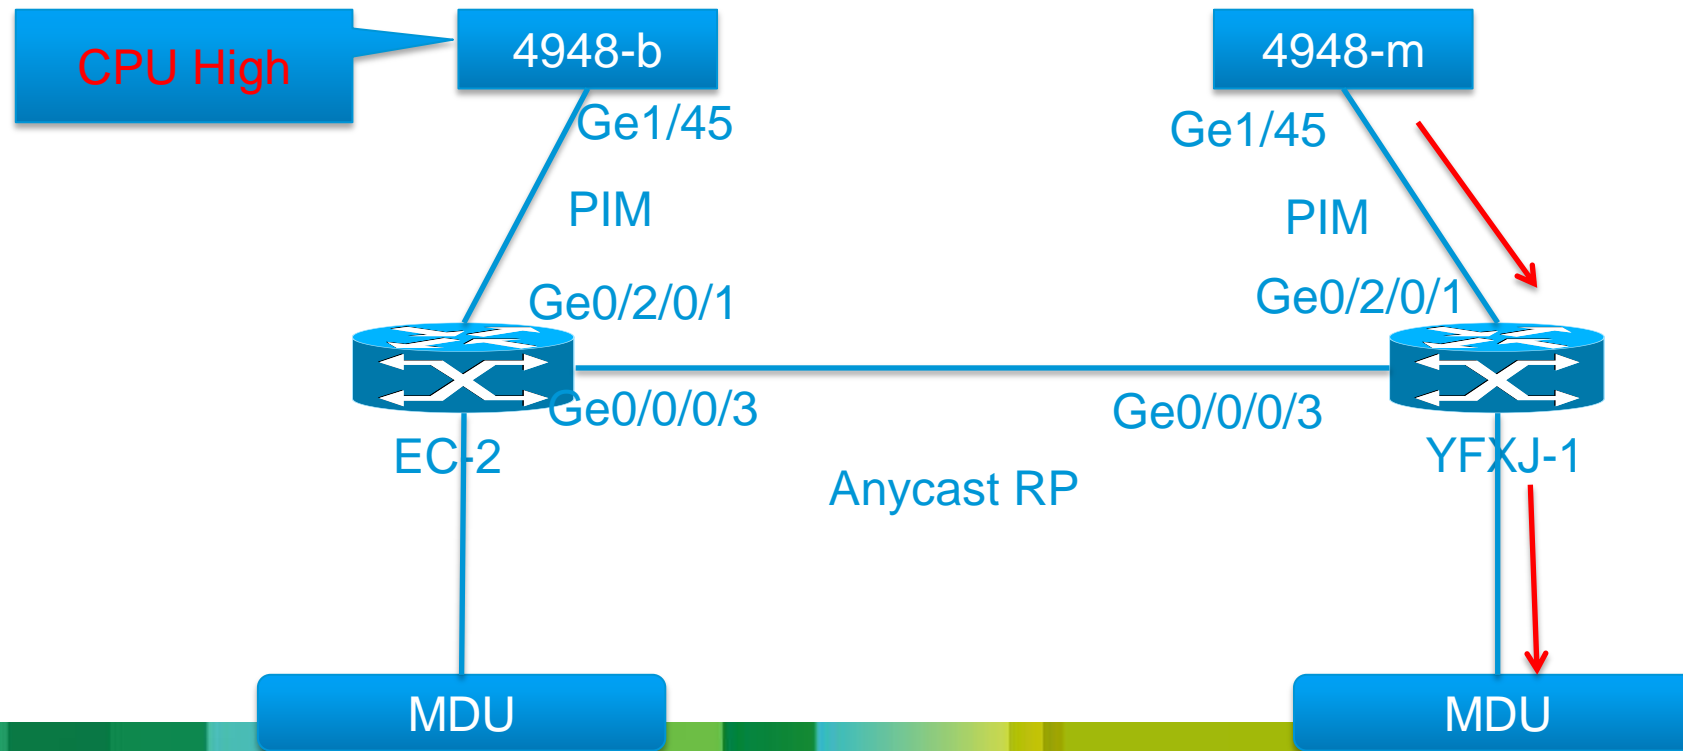
After EC-2 reload then boot up, check the pim entry on EC-2, did not observe any (S,G) entry. Check the interface connected to 0/2/0/1, do not receive any multicast traffic from 4948-b.

Ask JSBC to check the status of 4948-b, the device is hang due to high cpu utilization.

Then we shutdown the interface G0/2/0/1 to change the RPF interface and expect to recover the service.

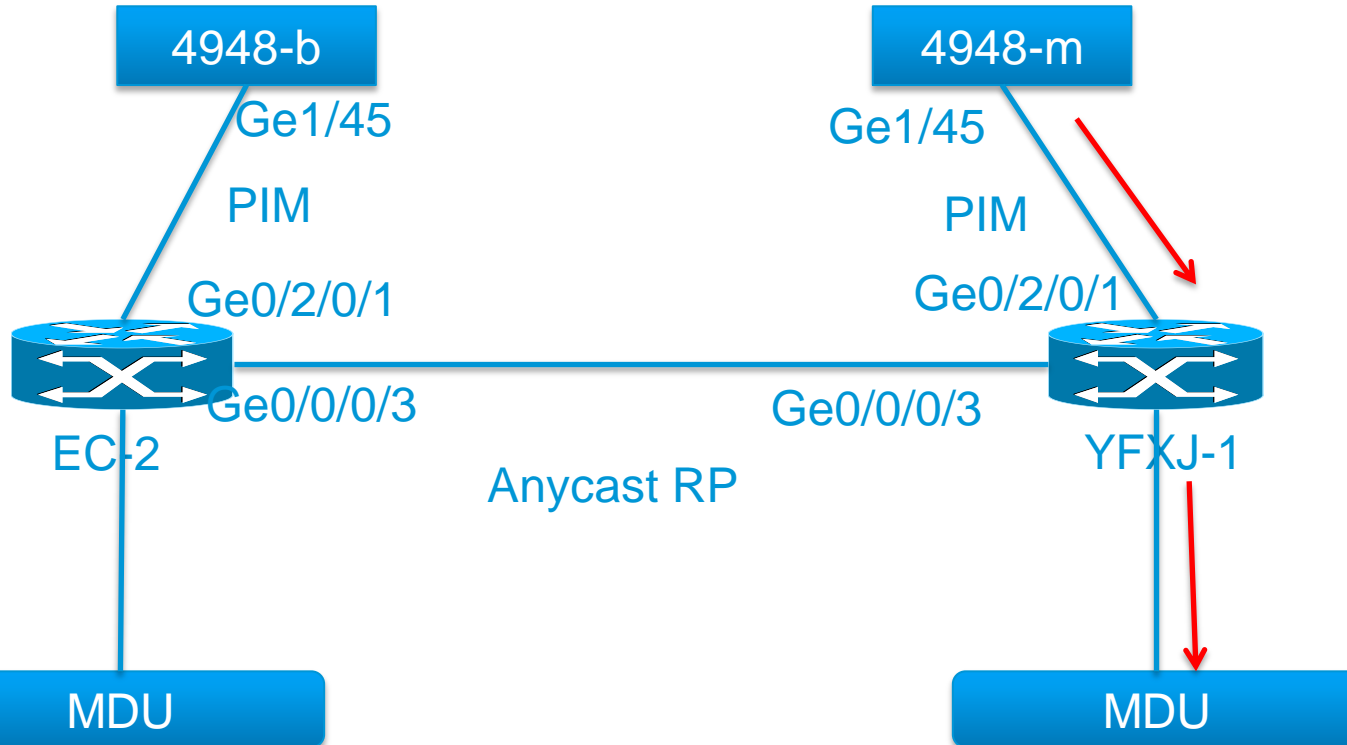
Due to missed the FLAG 'RR' On (S,G) entry, so it can no info device to generate the MSDP SA Cache.
'Clear pim topology' still can not recover.

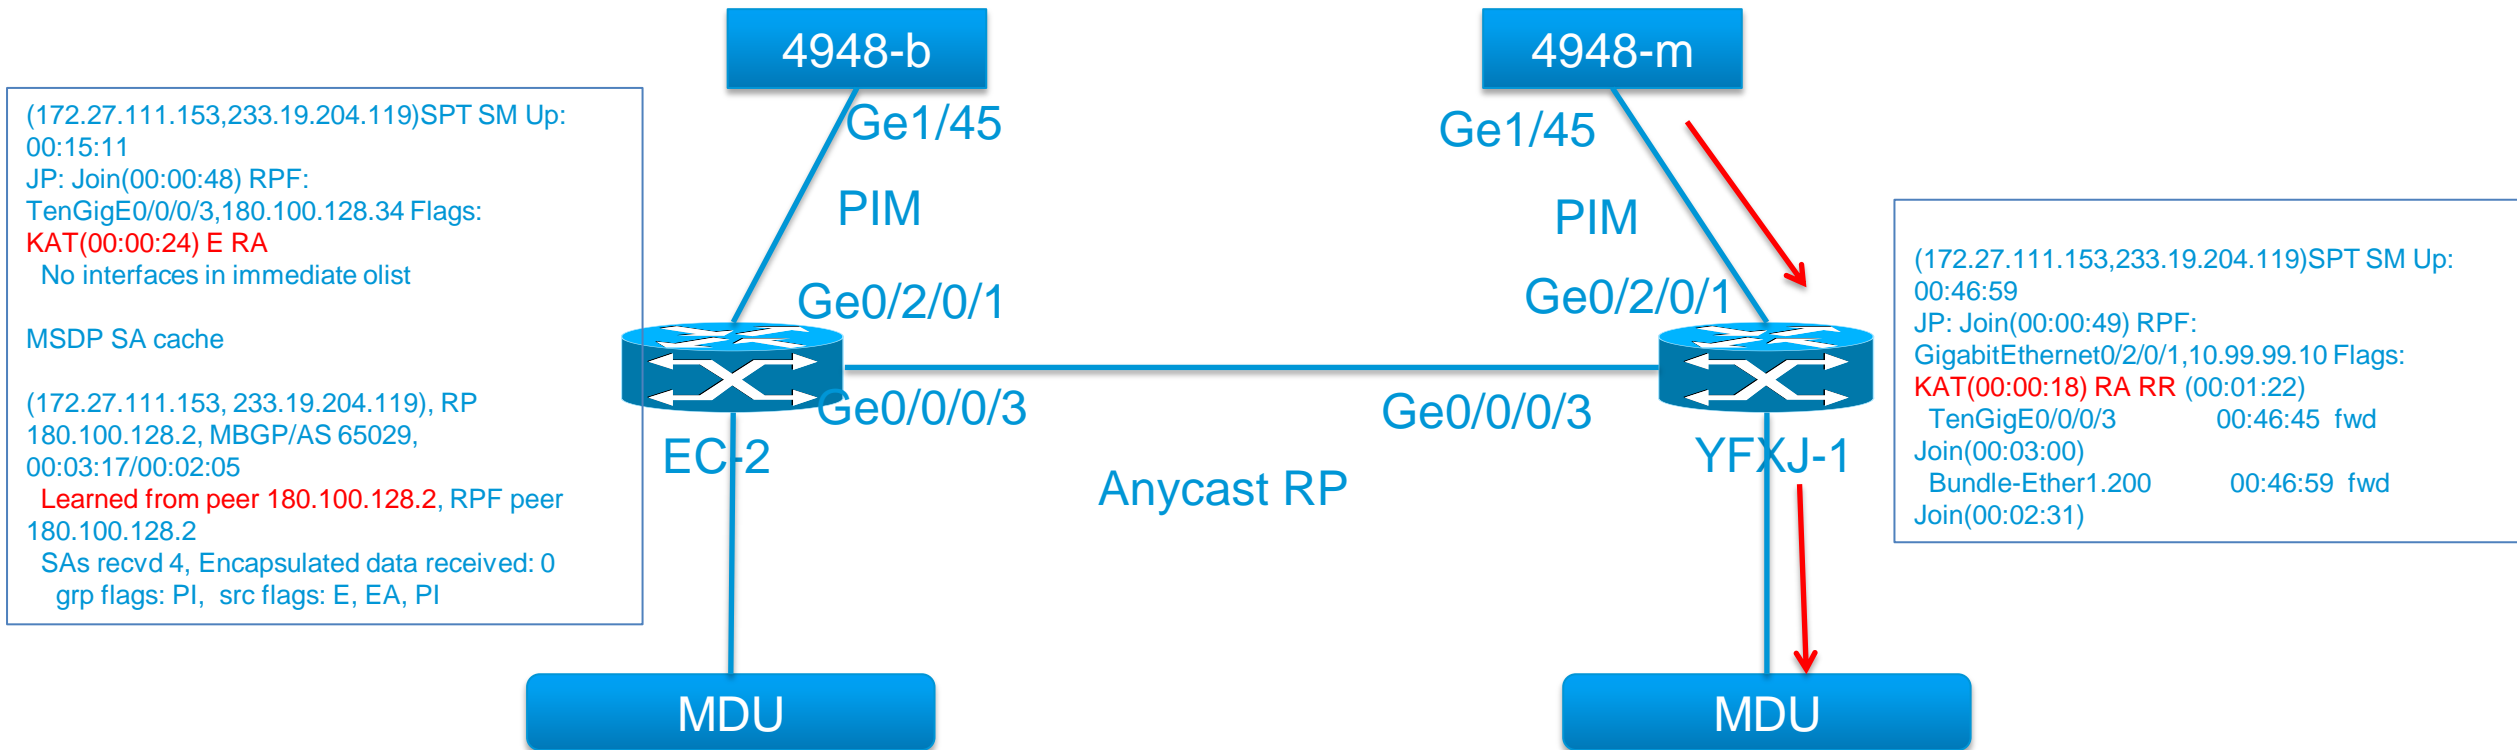
Issue Recovery

Only the recovery method is reload the CPU high device 4948-b.
 After reload the pim entry on YFXJ-1 will change to expectable status.
 Why reload the device 4948-b, will impact the status on YFXJ-1?

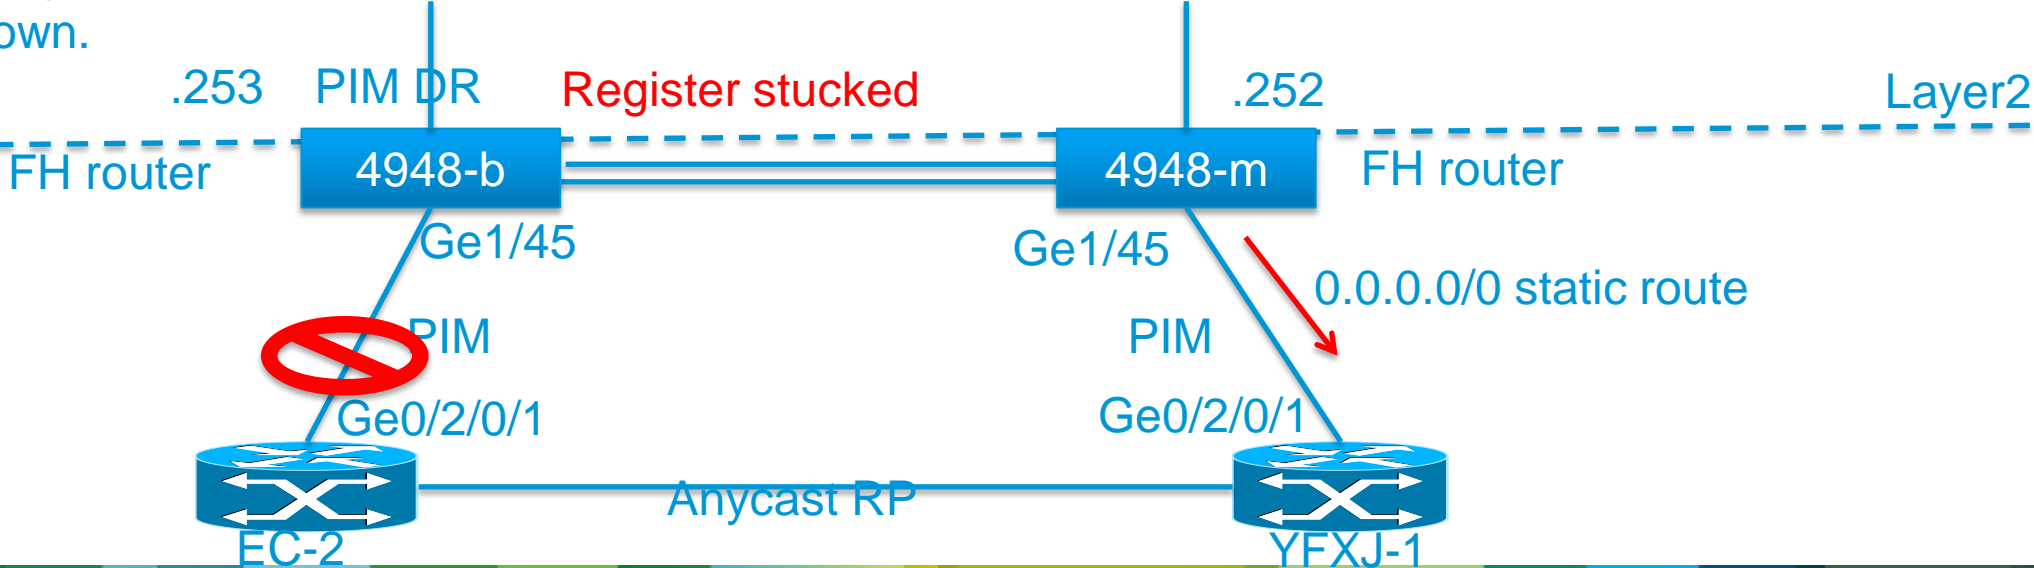
Root Cause

In RP KeepaliveTimer(S,G) is restarted at the RP when packets arrive on the proper register tunnel interface. So the KAT and RR flag only set after receive the register packets from DR.

When the 4948-b restart the RP will be switched to 4948-m, so 4948-m sends out the register packets, and service recovery. But if the 4948-b boot up. The service still will be down, if the interface between EC-2 and 4948-b still down.

Propose customer to set up backup static routes pointed to RP.
