Cisco 2100 Series Wireless LAN Controllers Best Practices

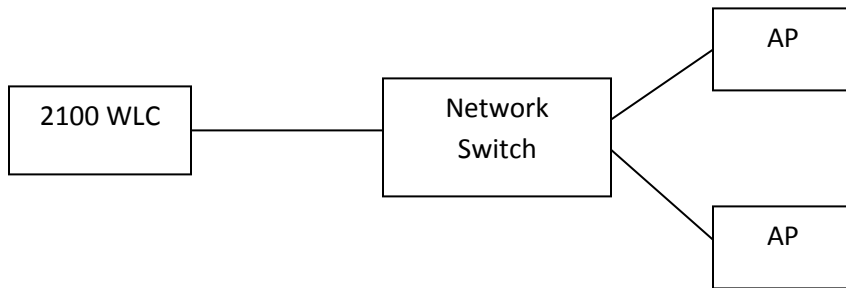
Example 1: Best Practice - Only a single network connection between the WLC and the switched network. APs are not directly connected to the WLC, but instead are connected to a network switch.

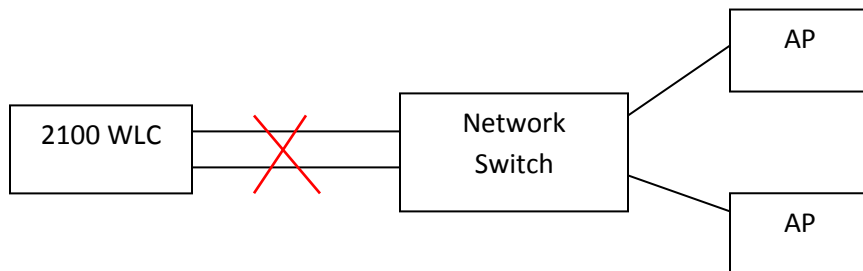
Example 2: Incorrect - Multiple connections from the WLC to the switched network.

The traffic flow problems that result from multiple network connections stem from two major causes. The first is that when you have multiple network connections to a WLC, you must either use link aggregation (LAG) or have an ap-manager interface assigned to each port. This ensures proper traffic flow into and out of the WLC. With the 2100s, however, you cannot configure more than one ap-manager interface and LAG is not supported. The second issue is that all of the interfaces on a 2100 use the same MAC address. This fundamental design aspect is the underlying cause for the following bugs filed against the 2100 series controllers:

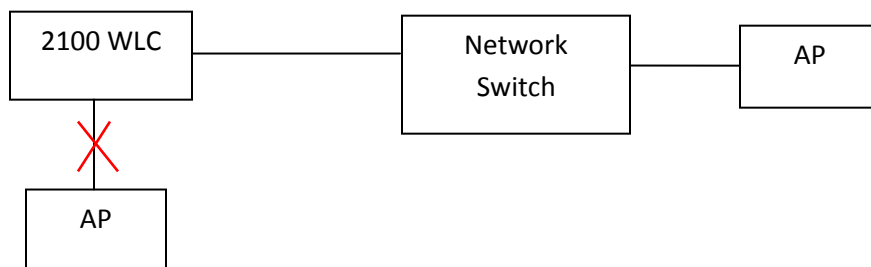
Example 3: Incorrect - Although there is only a single network connection between the WLC and the wired network, APs are directly connected to controller.

Aside from the physical connections, it is also important to point out that certain features such as Telnet, SSH, and Syslogging from an AP that is directly connected to a 2100 series WLC will fail unless that AP is registered to the controller. This can be an issue with remote deployments in the event that the AP is not joined and you need to take advantage of those features.

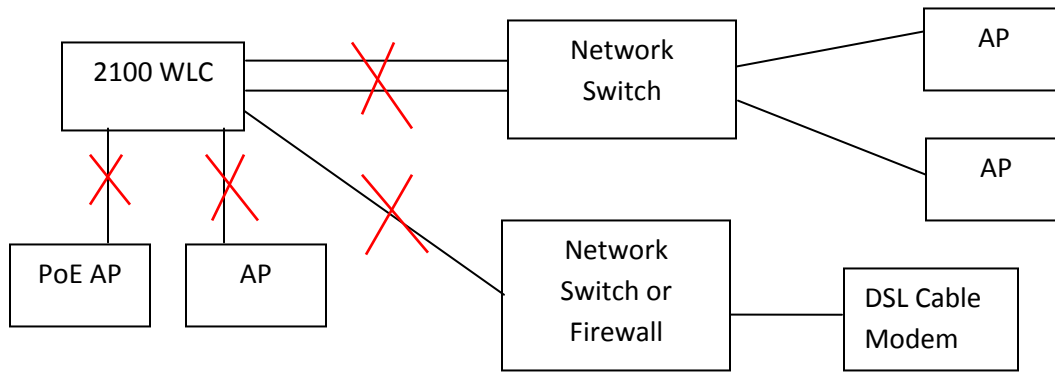
Example 4: Incorrect - multiple connections to the wired network from the WLC and APs directly connected to the controller. One of the directly connected APs is using PoE.
