# Cisco TelePresence System C/SX/EX/MX/Profile Series

Software release notes TC7

D1507118

June 2015

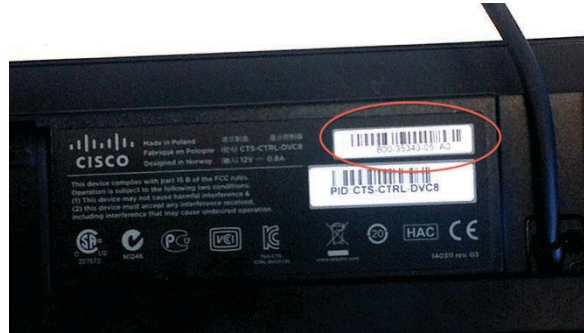
The TAN number can be found on the back of the Cisco TelePresence Touch 8 panel on the sticker positioned in the upper right corner.

Identify the minimum software supported by using the TAN number with this table.
