**Hard Drive in a CIVS-MSP shows up as
'Unconfigured(bad)'
Jim Sullivan 05-06-2011**

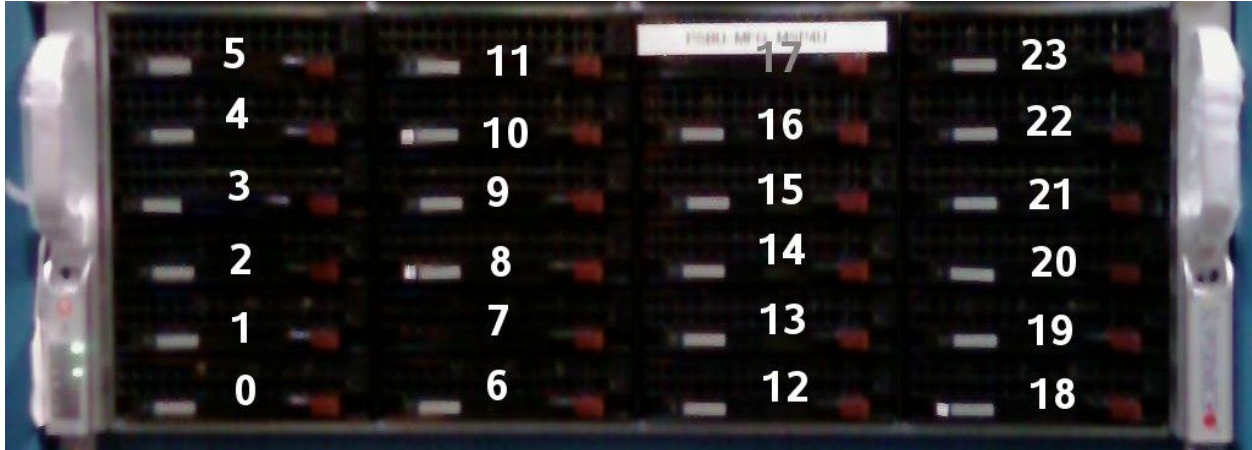
It's possible a hard drive may show up as 'unconfigured(bad)' within the raid configuration. This could be experienced when replacing a drive that has failed, or simply show up because a single drive encountered errors and did not properly recover. Below is a procedure I have captured to add the 'unconfigured(bad)' drive back to the existing array.
